City of Ryde

Water Quality Monitoring Report Spring 2023 & Autumn 2024

Report Name: City of Ryde Water Quality Monitoring Report
Spring 2023 and Autumn 2024

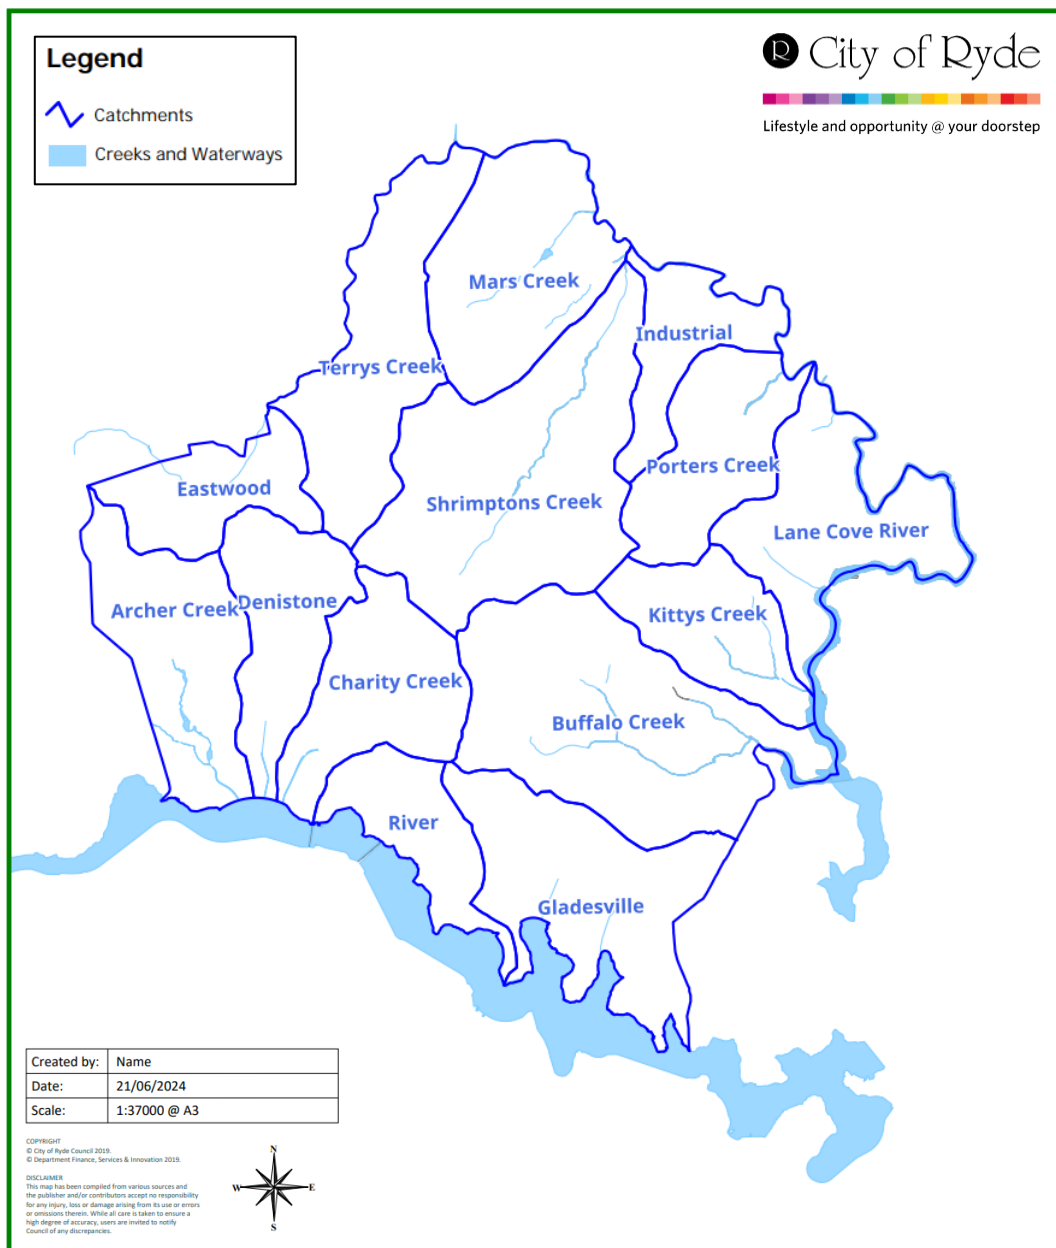
Figure 1 City of Ryde Water Quality Management Program Sites Map of sites for chemical and ecological monitoring across five creeks

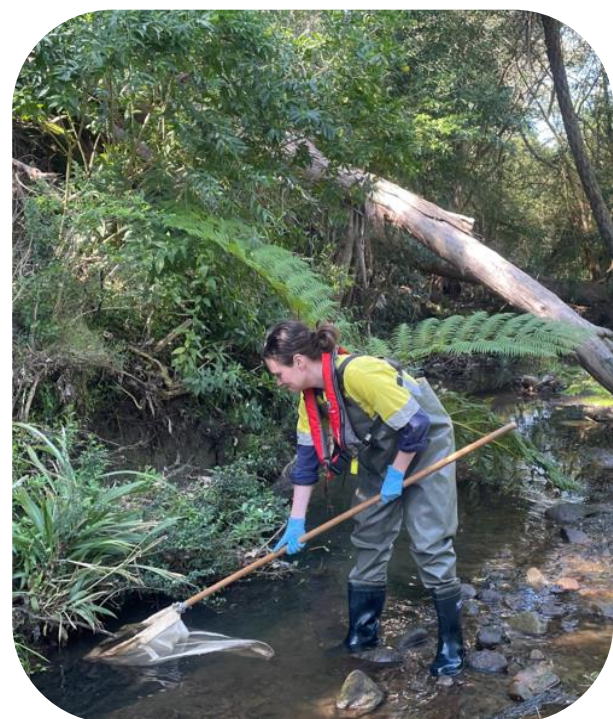
For this project, two replicate macroinvertebrate samples were collected at each of the five core sampling sites. Collection was performed using a fine mesh net to upwell the water and dislodge the animals. After sampling macroinvertebrates were picked out from the debris, preserved, and taken to the laboratory for identification.

Figure 2 Collecting macroinvertebrates from Buffalo Creek (Spring 2023)

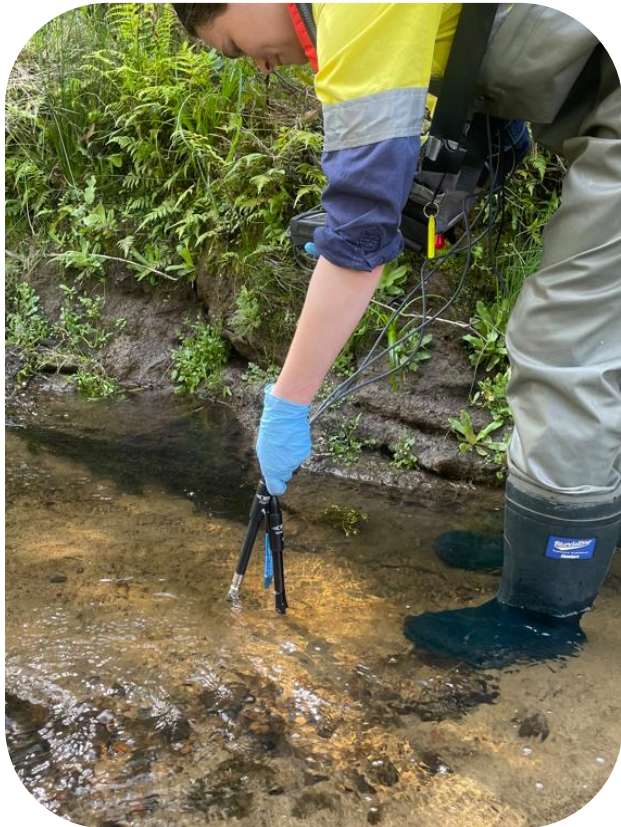
Figure 5 In-field water quality testing

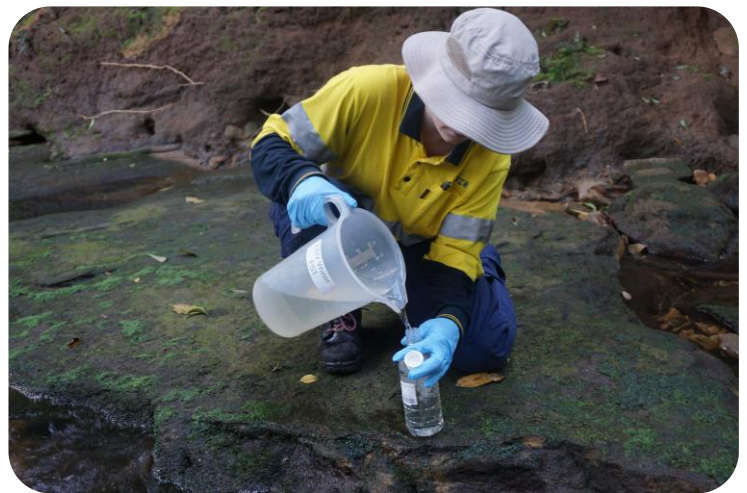
Figure 6 Collecting water samples for analysis

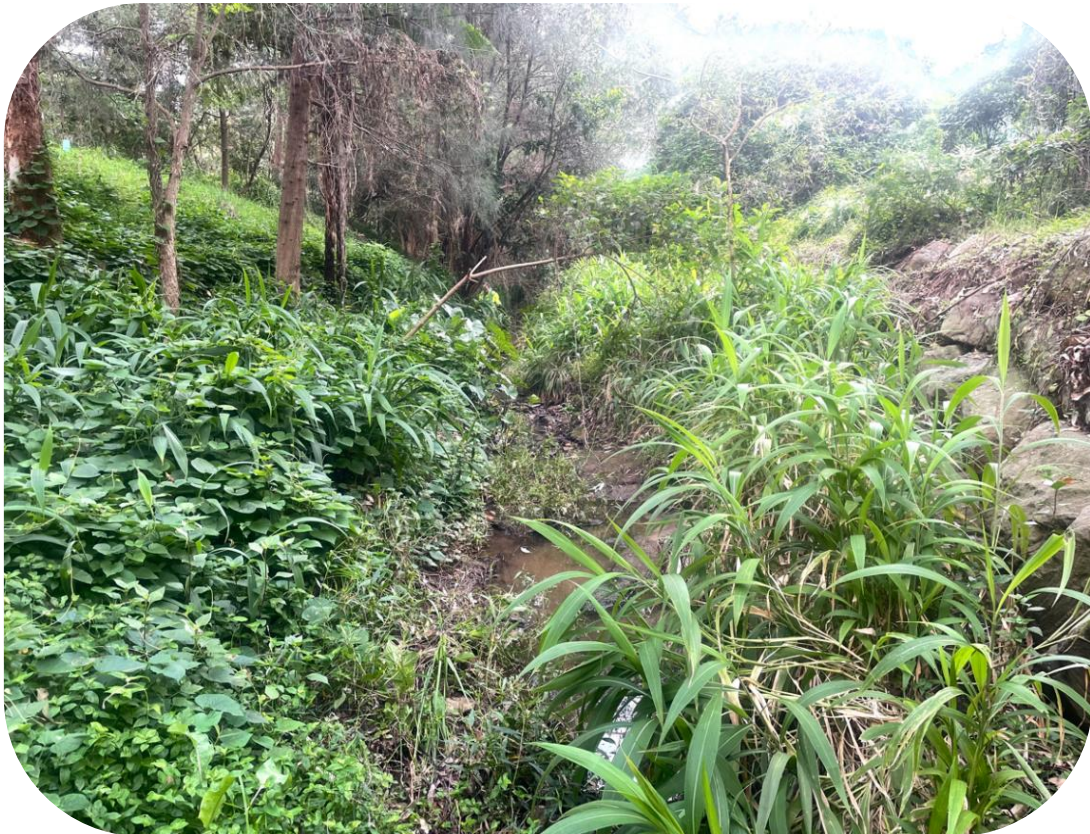
Figure 7 Archers Creek core site at Maze Park (CR2) looking upstream (Autumn 2024). This site has a consistently high density of riparian vegetation. This includes a range of weedy riparian types including: ground cover, shrubs, and an extensive tree canopy.

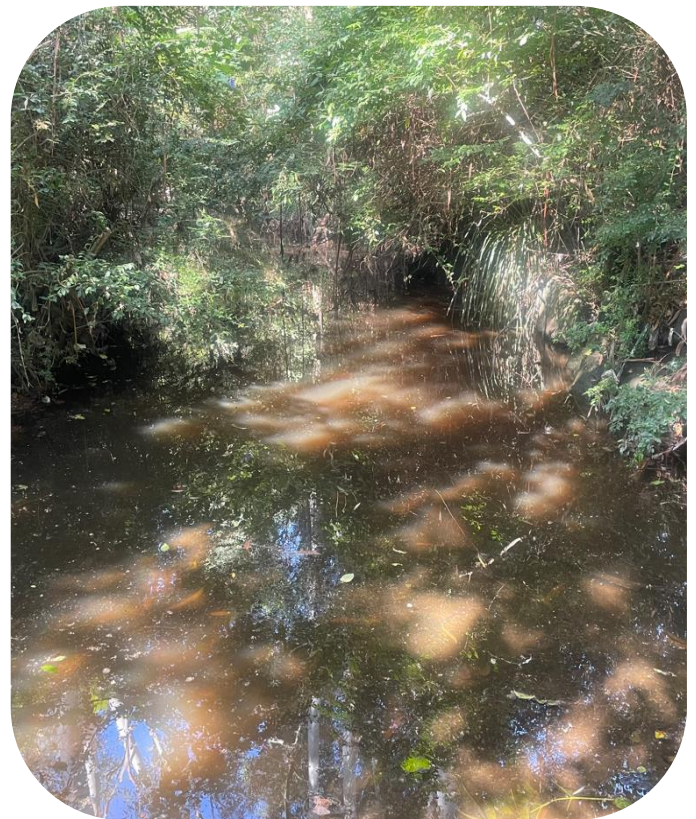
The Shrimptons Creek core site is located within Wilga Park in the suburb of Macquarie Park. Land use in this area is primarily residential, commercial, and light industrial. The creek flows through a thin riparian corridor, which is a combination of native and exotic species. The creek bed is predominately bedrock and sand/silt. During both Spring 2023 and Autumn 2024 (Figures 10 and 11) the downstream zone of the site had very low flow with only small, ponded areas

Figure 10 Shrimptons Creek at Wilga Park looking upstream (Autumn 2024)

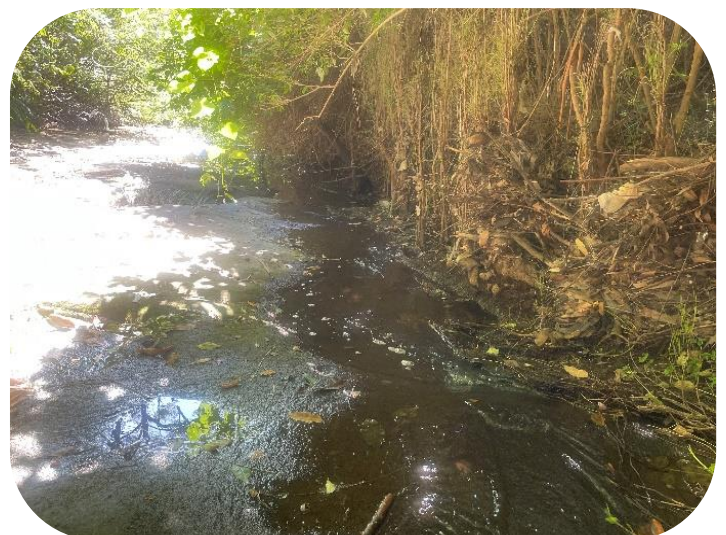
Figure 11 Shrimptons Creek at Wilga Park looking downstream (Autumn 2024)

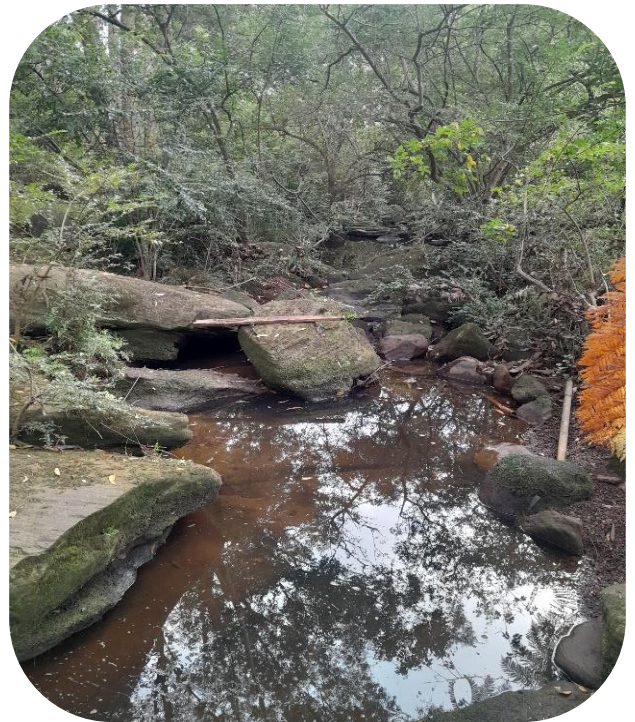
The Kent Road site is situated at ELS Hall Park amongst a residential area and is lined by a thin section of riparian vegetation comprised of native and exotic species that completely shades the creek (Figure 12).

Figure 12 Shrimptons Creek at Kent Road looking downstream (Autumn 2024)

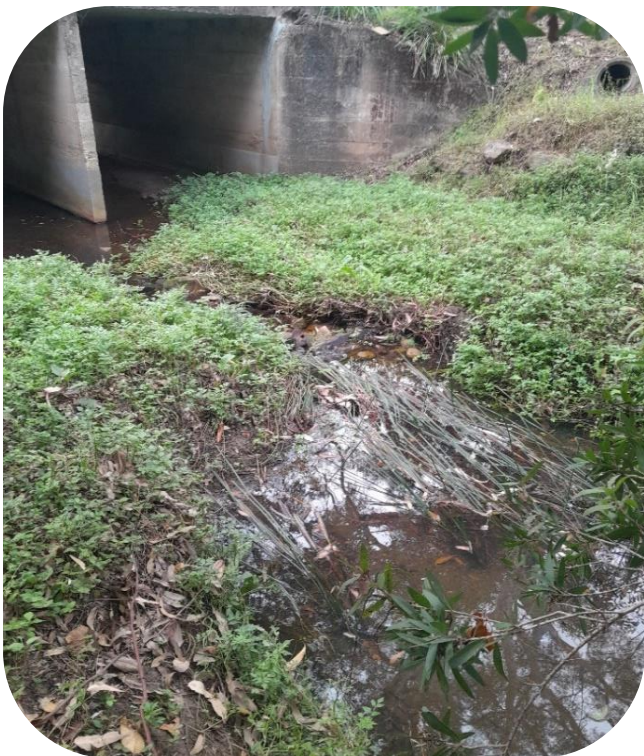
This site is located at the downstream section of Santa Rosa Park, just before it flows under Bridge Road and is surrounded by residential areas (Figure 13). Revegetation of the riparian area has enhanced the physical buffer improving bank stabilisation and filtration.

Figure 13 Shrimptons Creek at Bridge Road looking downstream (Autumn 2024)

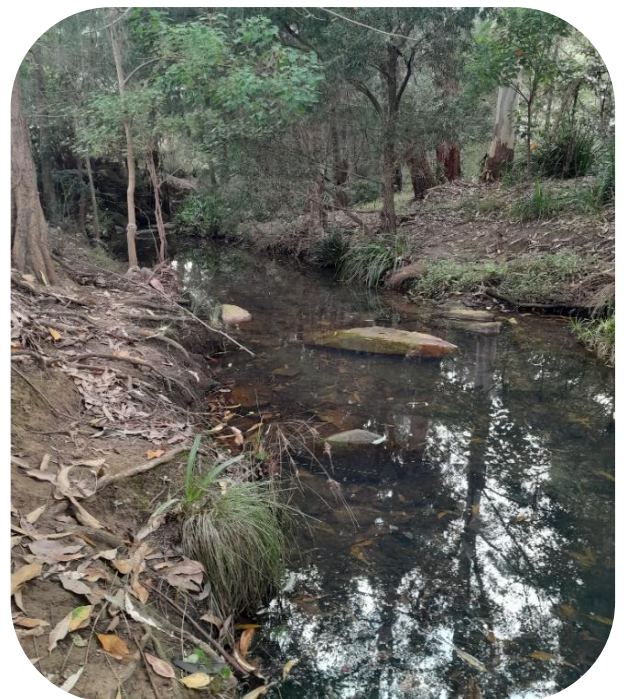
CR1SC Shrimptons Creek at Quarry Road

Figure 14 Shrimptons Creek at Quarry Road looking downstream (Autumn 2024)

The Quarry Road site is located at the upstream section of Santa Rosa Park, at the point where Shrimptons Creek emerges from the underground stormwater system (Figure 14). This site has sandstone blocks around the drain for bank stabilisation.

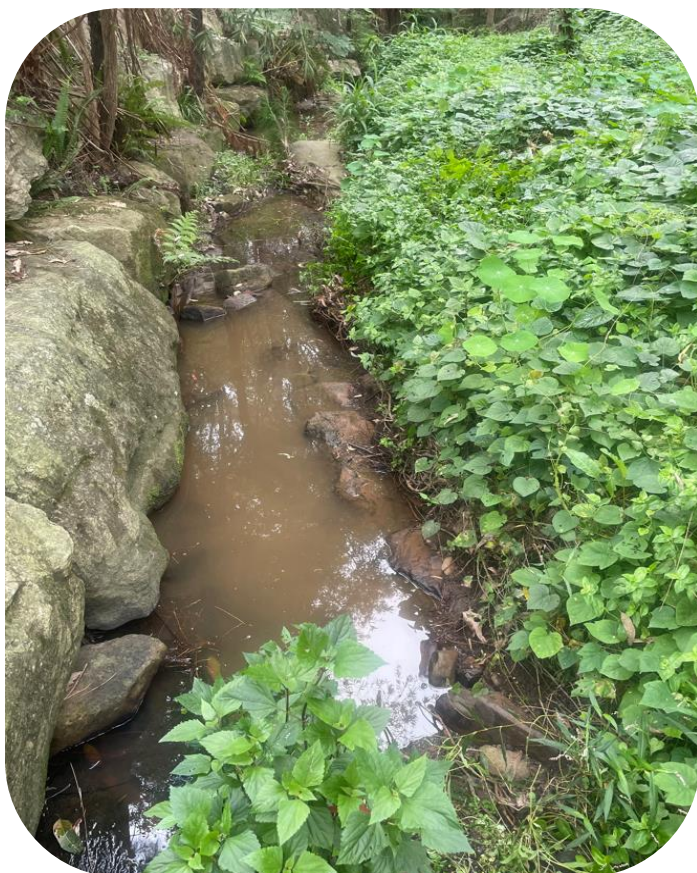
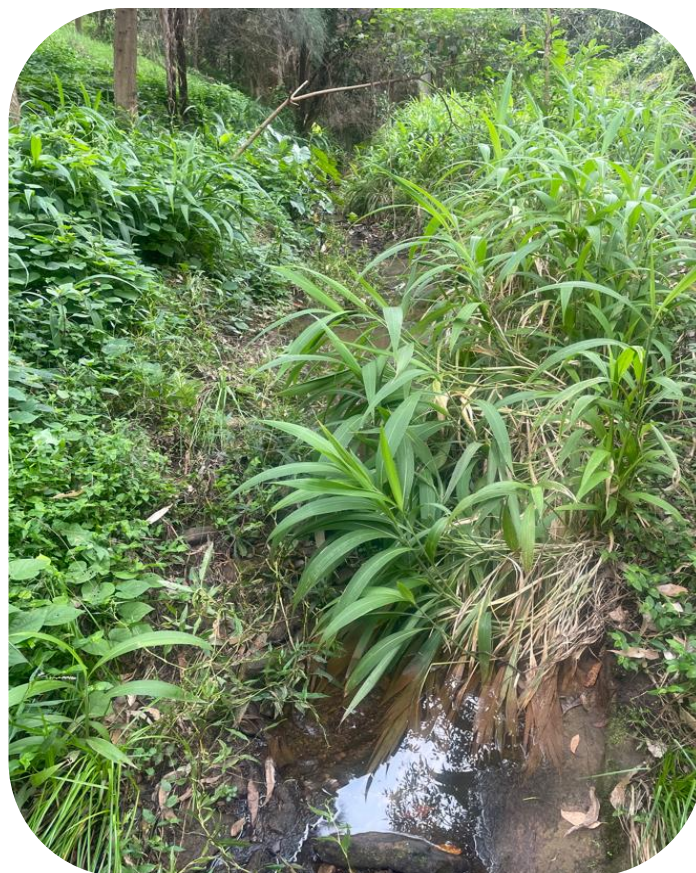
This site is located in Maze Park, West Ryde and is upstream of the Victoria Rd crossing (Figure 18). The land use upstream of this site is largely residential while a golf course is present downstream. The creek bed is mostly bedrock bordered by banks of sediment (sand, silt and organic matter, Figure 19). The creek channel has been previously relined with sandstone blocks. The vegetation within and adjacent to the creek is a combination of native and introduced species.

Figure 19 Archers Creek site at Maze Park looking downstream (left) and upstream (right), Autumn 2024

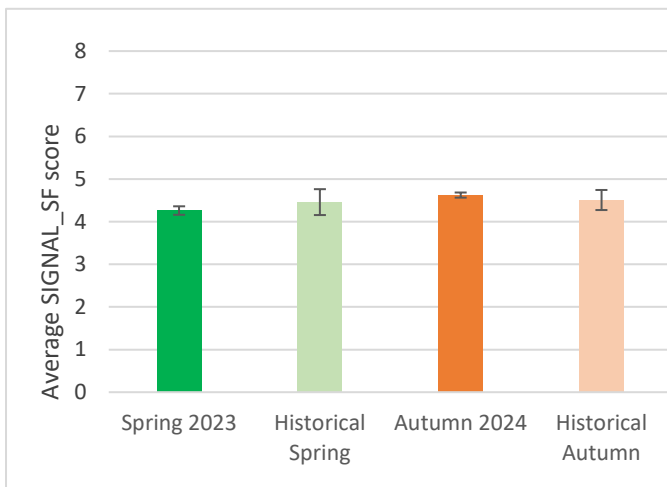
SIGNAL_SF results were comparable between seasons. The average result for Spring 2023 was 4.26 (Figure 20). This was consistent with the historical Spring average of 4.46. The Autumn 2024 result was slightly higher with an average of 4.62. As with Spring, this result was within range of the Autumn average (4.51).

Figure 20 Archers Creek average SIGNAL_SF results

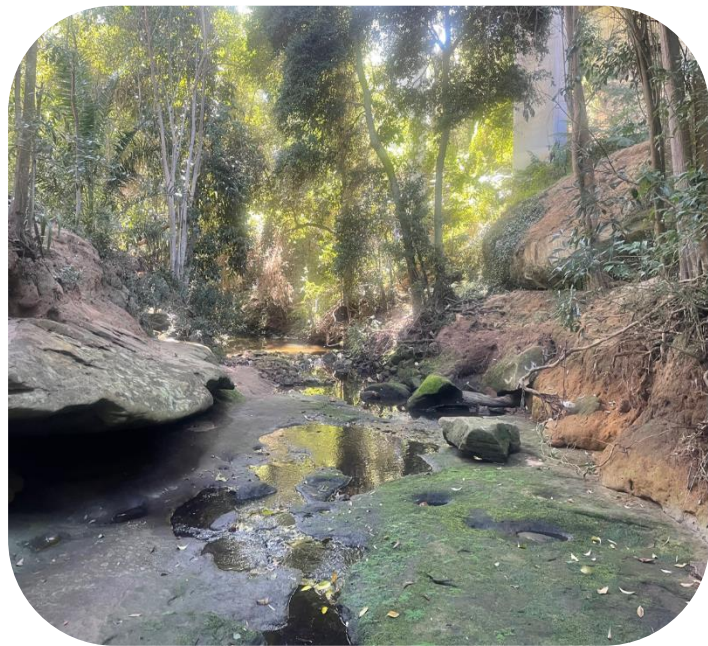
This site is located within Somerset Park under the M2 overpass in the suburb of Epping (Figure 23). The surrounding land use is residential, and the creek flows through a bushland corridor. The riparian area bordering the creek contains both native and exotic plant species. The creek bed is predominately bedrock, gravel, and sand (Figure 24).

Figure 24 Terrys Creek core site at Somerset Park (CR3T) looking downstream (Autumn 2024)

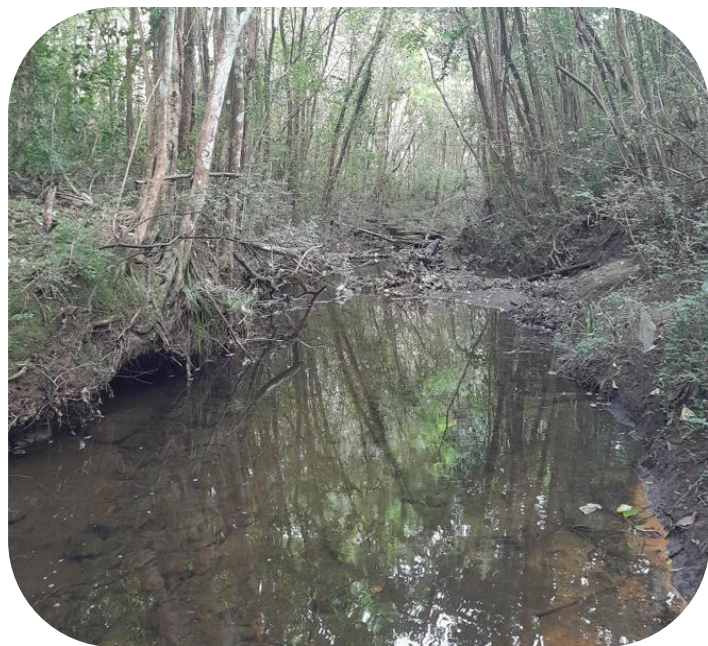
This site is located downstream of Terrys Creek Waterfall, which is an area surrounded by bushland (Figure 25). Dense vegetation covers both banks and consists of a mixture of native and introduced species. The bank is comprised of sediment (mostly sand and silt) and river rocks, which create riffle zones.

Figure 25 Terrys Creek site at Forrester Park (CR3TA) looking downstream (Autumn 2024)

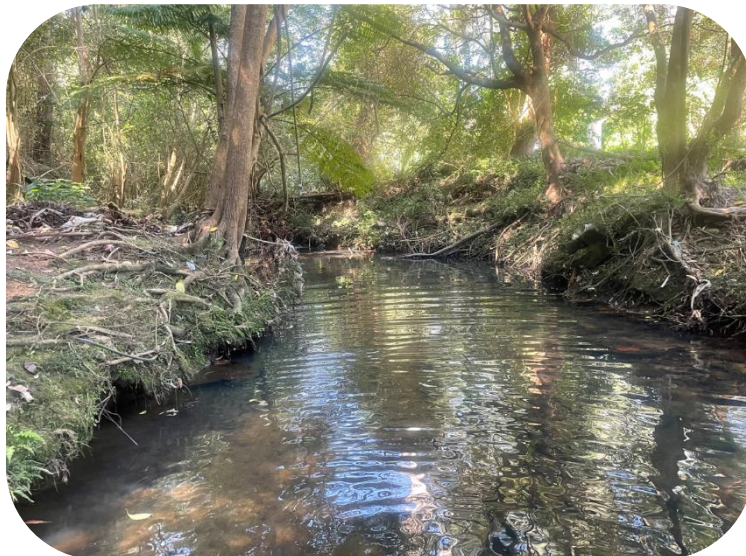
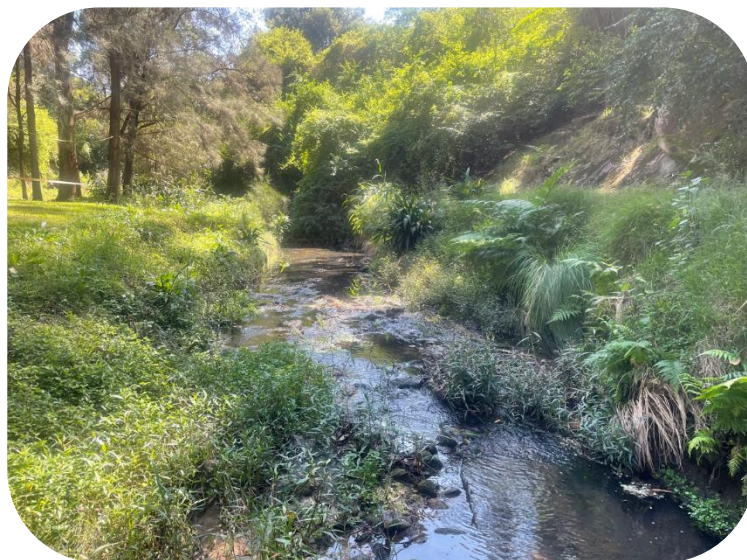
The creek bed is a mixture of sand, silt, and gravel. There is usually some macrophyte growth, (*Egeria* and *Potamogeton*), and a small amount of algal growth observed in the channel. Sedimentation has occurred in the creek channel periodically.

Figure 30 Buffalo Creek core site (CR4B) looking downstream, Autumn 2024

Figure 31 Buffalo Creek core site (CR4B) looking upstream, Autumn 2024

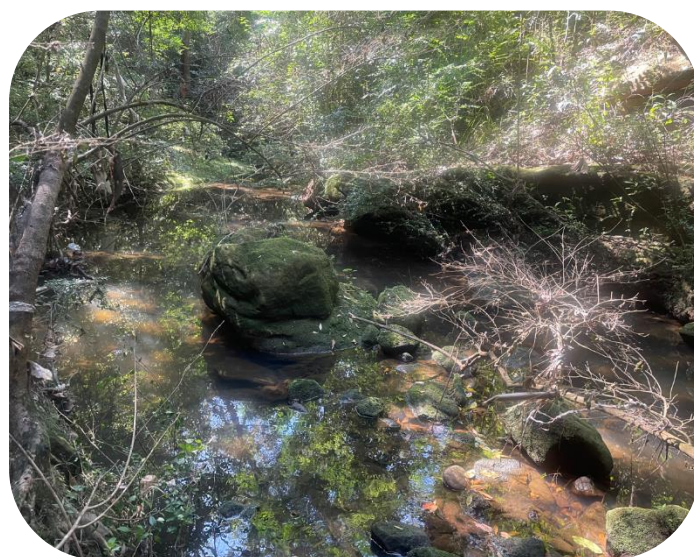
The surrounding riparian area is dominated by native plants with a small number of exotic species. The creek bed is mostly bedrock with some cobble, boulder, and sand. No macrophyte growth has been observed although there has been algal growth present.

Figure 38 Porters Creek core site (CR5P) looking upstream (left) and downstream (right) Autumn 2024

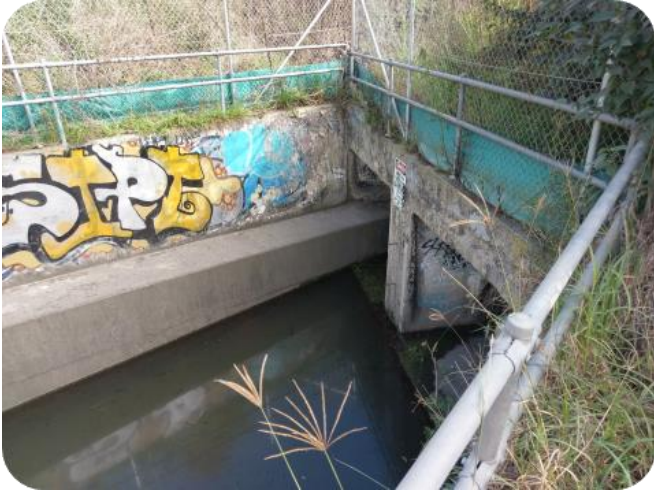
CR5PA Porters Creek at Main Branch

This site is located on the western boundary of the construction waste recycling facility and consists of an open concrete channel. Samples are collected from the retention basin at the end of the channel. During Autumn 2024 this site could not be accessed due to construction works in the area.

Figure 39 Porters Creek at Main Branch facing downstream

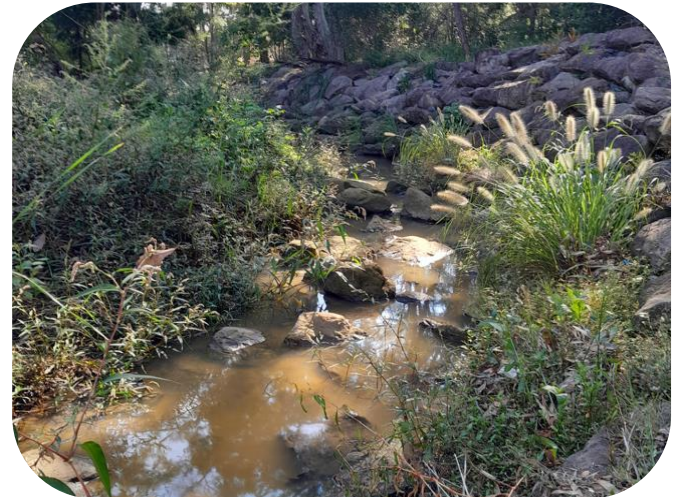
CR5PC Porters Creek at Wicks Road

This site is the first point that Porters Creek emerges from the underground stormwater system. The site is surrounded by commercial and industrial land uses. The banks have been re-lined with sandstone and surrounding area vegetated with native plants.

Figure 40 Porters Creek at Wicks Road, Autumn 2024

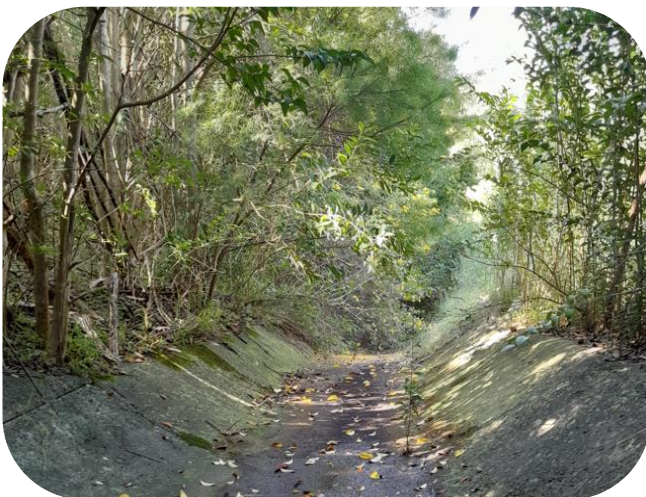
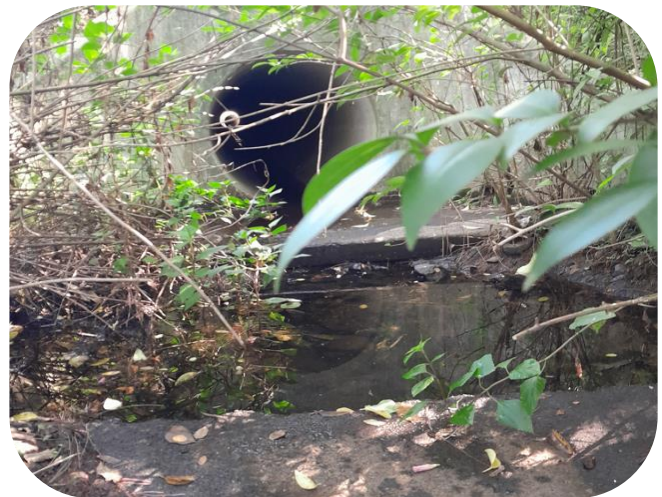
CR5PB Porters Creek at Spur Branch

This site is in the north-western corner of the centre in an underground drainage pit where several underground stormwater lines meet before joining and draining to the main Porters Creek line (Figure 41). During Autumn 2024 the channel was mostly dry but there was a pooled section at the top that could be accessed.

Figure 41 Porters Creek at Spur Branch channel looking downstream (left) and pooled section in the upper channel (right) Autumn 2024

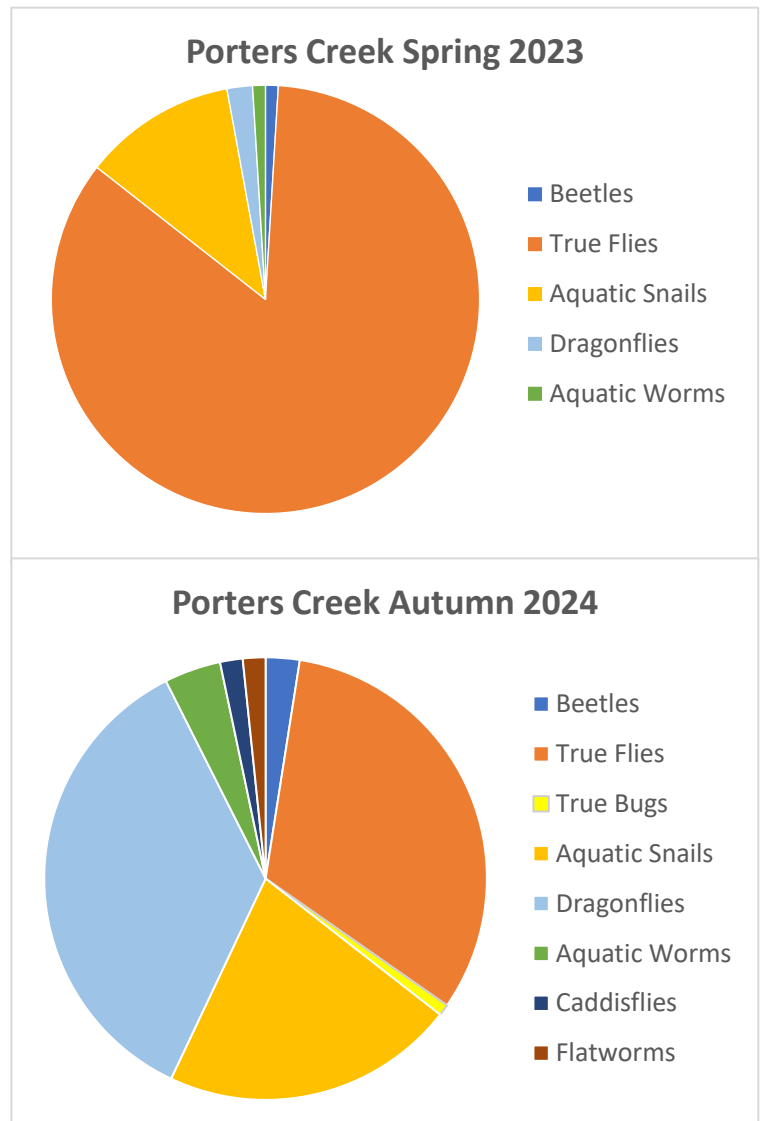
Figure 44 Porters Creek community composition charts for Spring 2023 (top) and Autumn 2024 (bottom)

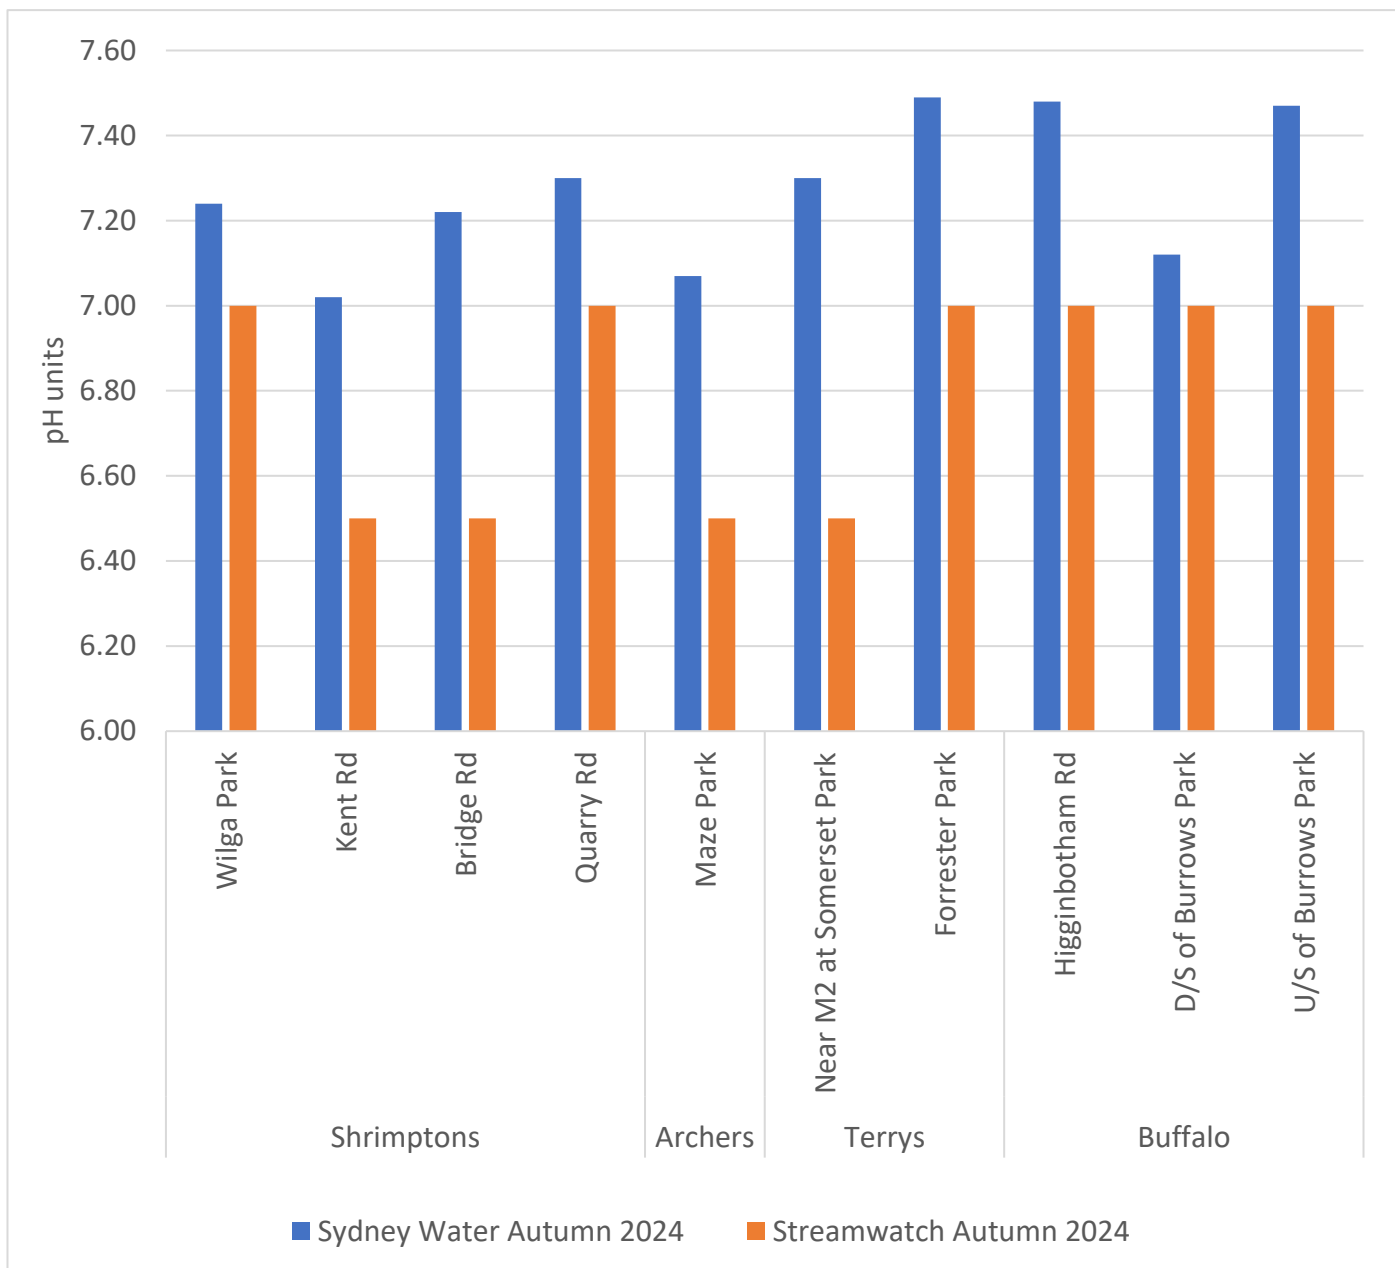
Sydney Water recorded higher pH results when compared to Streamwatch data at all sites.

Figure iii Autumn 2024 pH data from Sydney Water and Streamwatch sampling
